HAILSTORM DAMAGE TO *HEVEA* TREES IN TRIPURA AND THE PERFORMANCE OF THE RECOVERED TREES

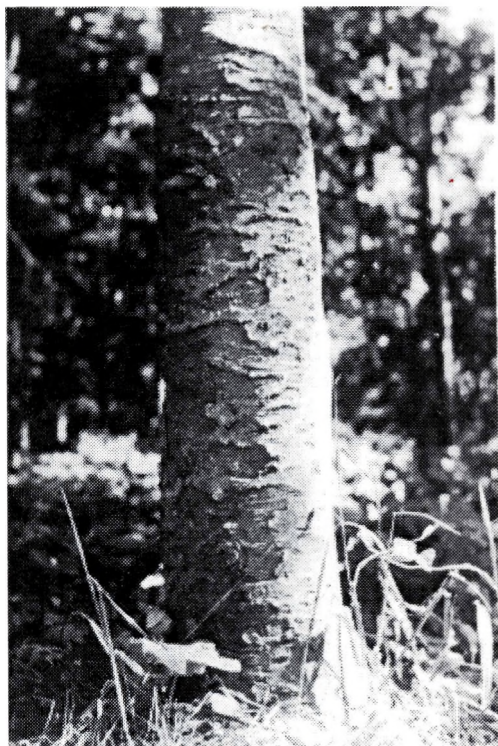
The data for this investigation was recorded from a clone evaluation trial planted in randomised block design at the RRII research farm at Taranagar during 1980 with eight clones and three replications. On 3rd April, 1986 a severe thunderstorm carrying large sized hails measuring upto 7.5 - 12.5 cm in diameter, with a wind velocity more than 100 kmph hit the farm from North - North West direction. The high velocity hail chiselled the bark of the trees almost entirely on one side inflicting various degrees of damage from superficial to deep. In addition, common wind damages like branch and trunk snaps and splitting of trunk also occurred. It took almost two years for the affected trees to heal the wounds, by putting callus growth, though all the damaged trees were treated with wound dressing compounds immediately. The regenerated bark was having many protruberances and small cavities interspersed with islands of virgin bark which escaped the hail impact. The opposite side of the trunk had normal virgin bark (Figures 1 & 2).

Fig. 1. Hailstorm hit side of a tree showing protruberances and islands of virgin bark after recovery

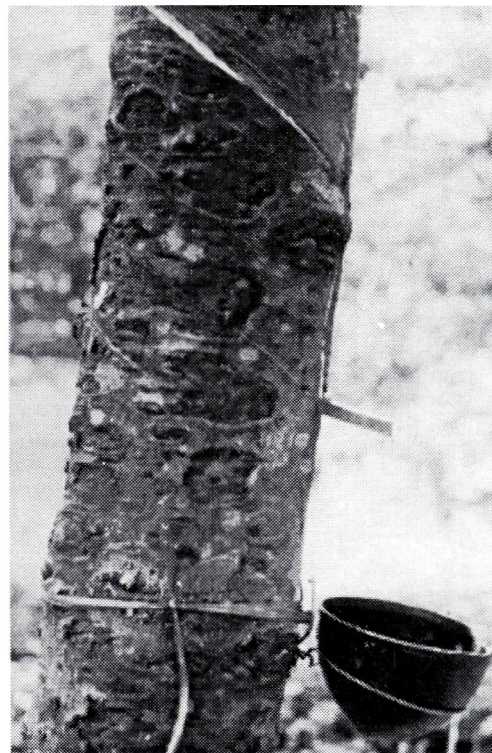
Four years after, the trees with an average girth of 50 cm were opened both on normal and damaged sides alternatively and yield was monitored separately. The affected side showed considerable depression in yield compared to that from the virgin bark. For refining the experimental procedure, four trees were selected per replication and given quarter spiral cuts both on affected and unaffected sides and a tapping system of $2\frac{1}{4}$ S d/2 6d/7 100 per cent was maintained throughout the study.

Fig. 2. Damaged side opened for tapping
